# Manhole Inspection Summary

Manhole # S13CC2018MH

Insp Date: **7/27/06 8:53 AM**

**Location** Address: **5736 RIDGEDALE RD**

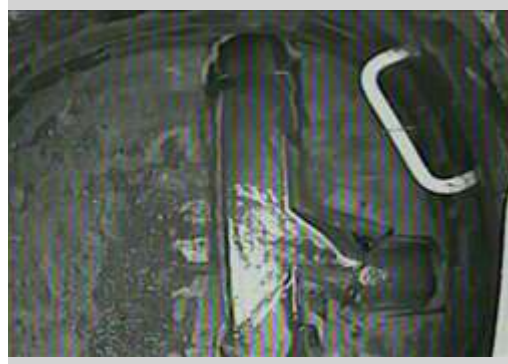
Top View

Bench debris.

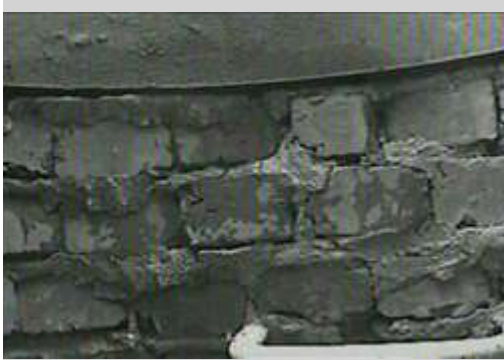
Defect

Frame leaks. Adjustment and Corbel deterioration and infiltration.

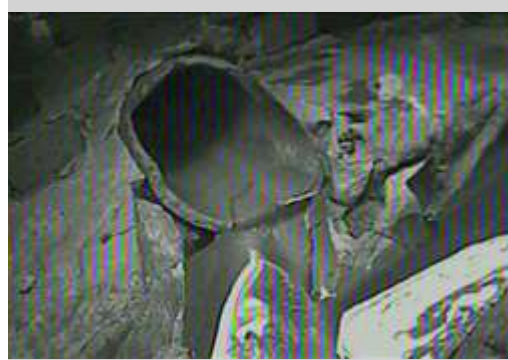
Defect

Channel cracks and deterioration.

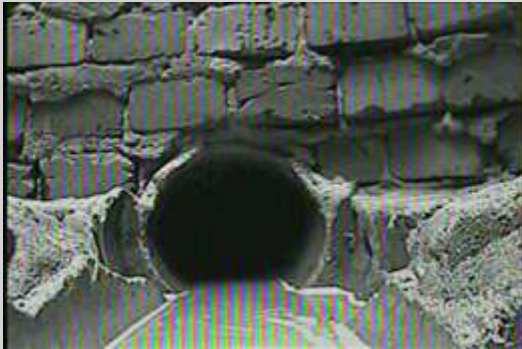
### 6 in. Circular Gravity Sewer Pipe Out @ 12 O'Clock

Barrel deterioration and infiltration. Channel cracks.

Infiltration: **Evidence** Pipe Seal Cond: **Unknown**

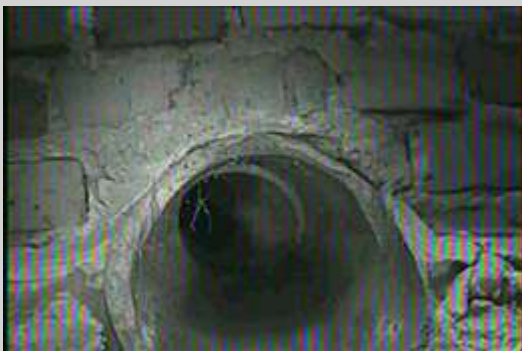
### 6 in. Circular Gravity Sewer Pipe In @ 3 O'Clock

Infiltration: **Evidence** Pipe Seal Cond: **Cracked**

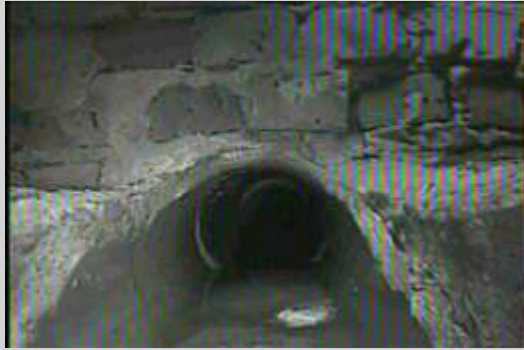
Pipe In @ 6 O'Clock

Barrel deterioration and infiltration.

Deposits: ☐ None ☒ **Mud** ☐ Sludge ☒ **Debris** ☐ Grease

Infiltration: **Evidence**
